THE JIMMY'S ANCESTRY

The CCKW in Detail and
The Collector's Syndrome

Part VII

The Fourth-Series:

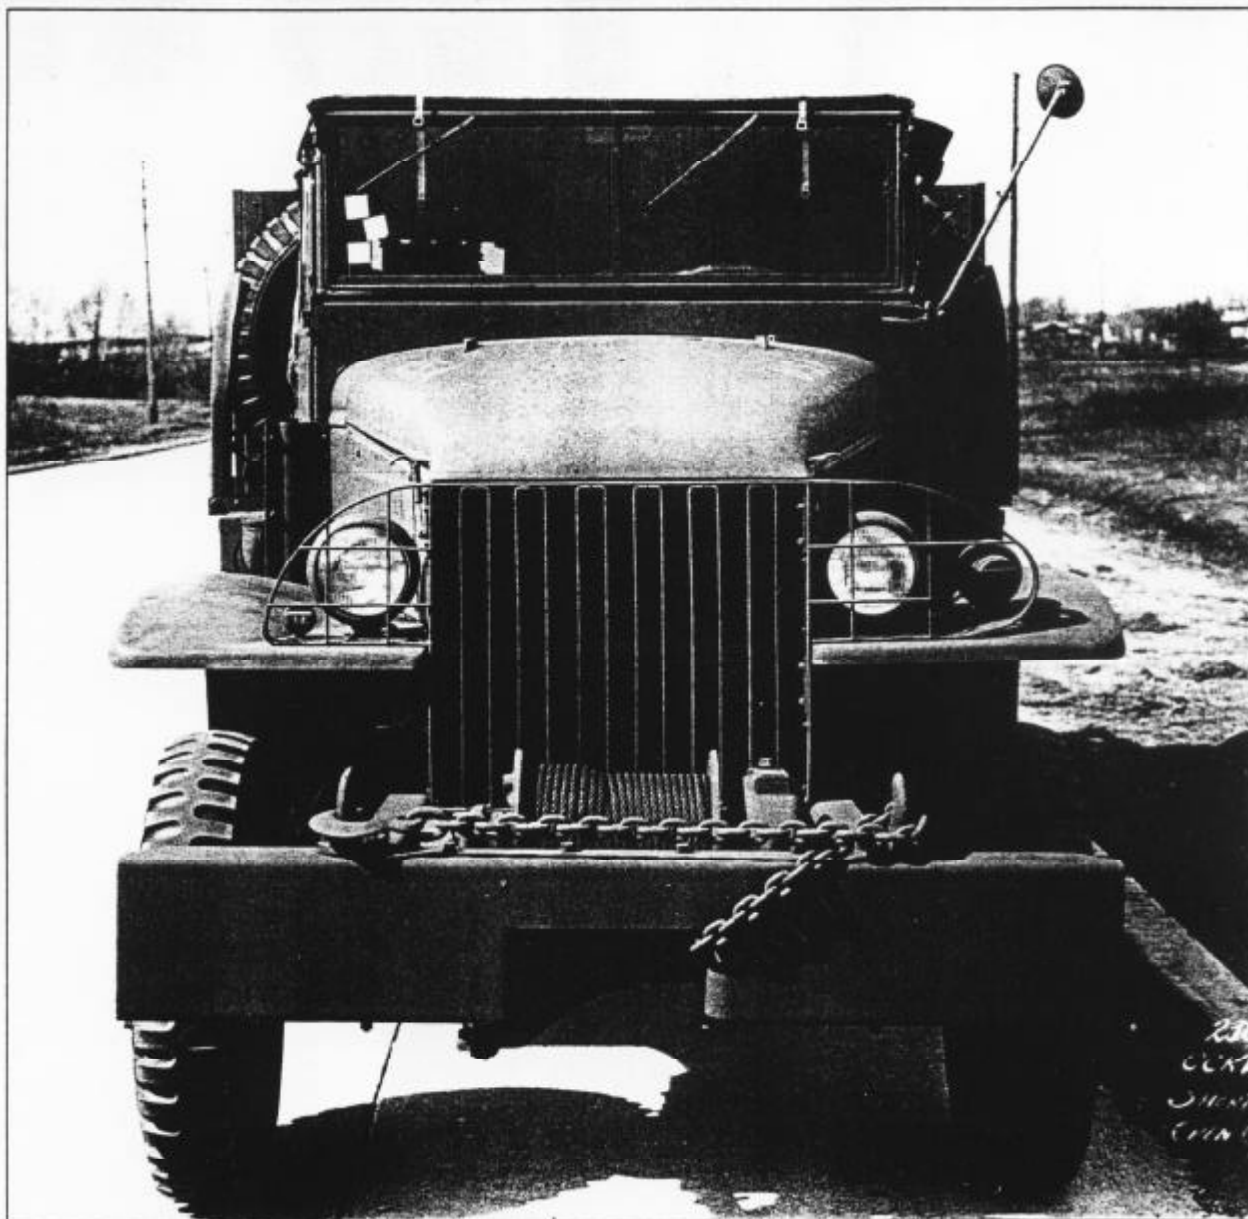
GMC T&C #280016

Front view of an early fourth-series CCKW-352. The GMC logo is long gone from the brushguard, but the very obsolete 4" registration numbers still linger on in the May 1943 portrait view. May 13, 1943.

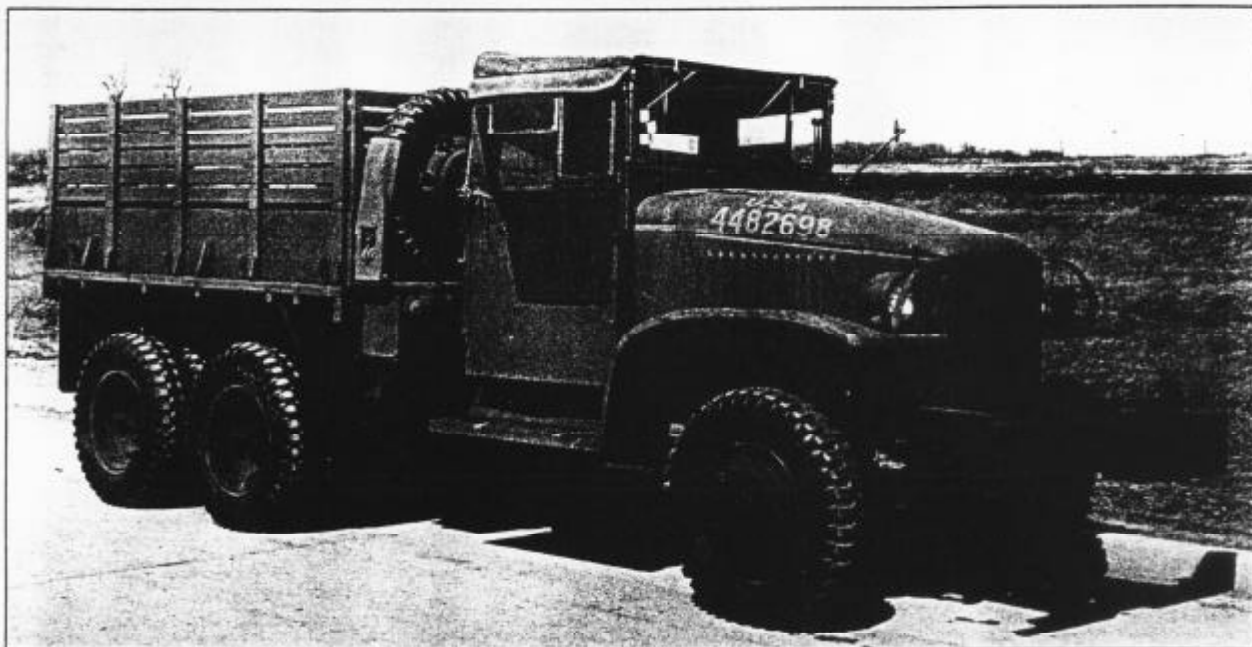
GMC T&C #2800-13

Right-front 3/4 Portrait view of a true classic. Points of interest to the collector in this May 1943 view: the last use of the large 4" numbers, the early style (1942/43) canvas with the floppy top and the large/small side curtain windows. Note also, no gas can holders on the running boards, but the large gas fillers have appeared. And, of course, the standard wartime wooden cargo body. Less than 10% of the CCKW's were the short wheelbase version. April 13, 1943.

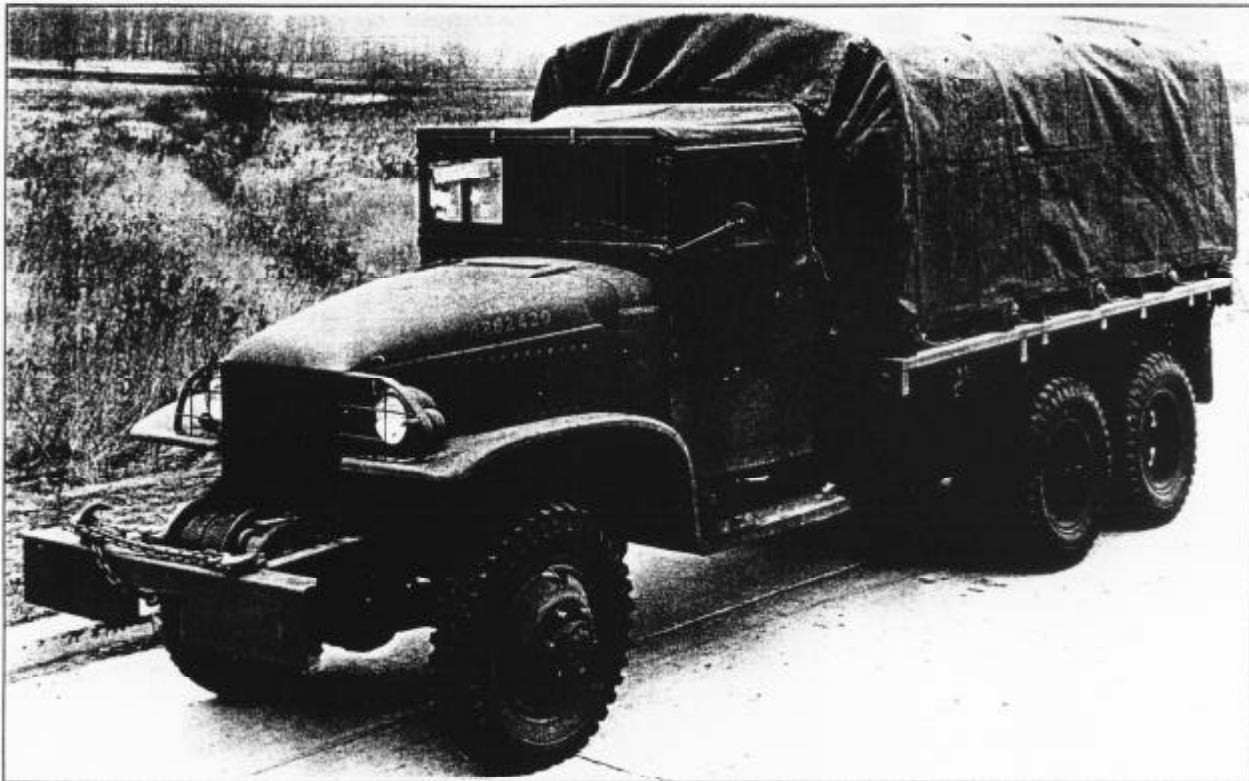
A real late fourth series truck. It still has the 1942/43 style wooden cargo bed, but it has the very late improved cab with the revised, late style large windowed doors, and the much tighter metal side rail reinforced top. Just barely visible you can see the shovel stowed on the running board. Yes, the small 2" regulation registration numbers finally appeared on CCKW's in mid 1943. January, 1944.

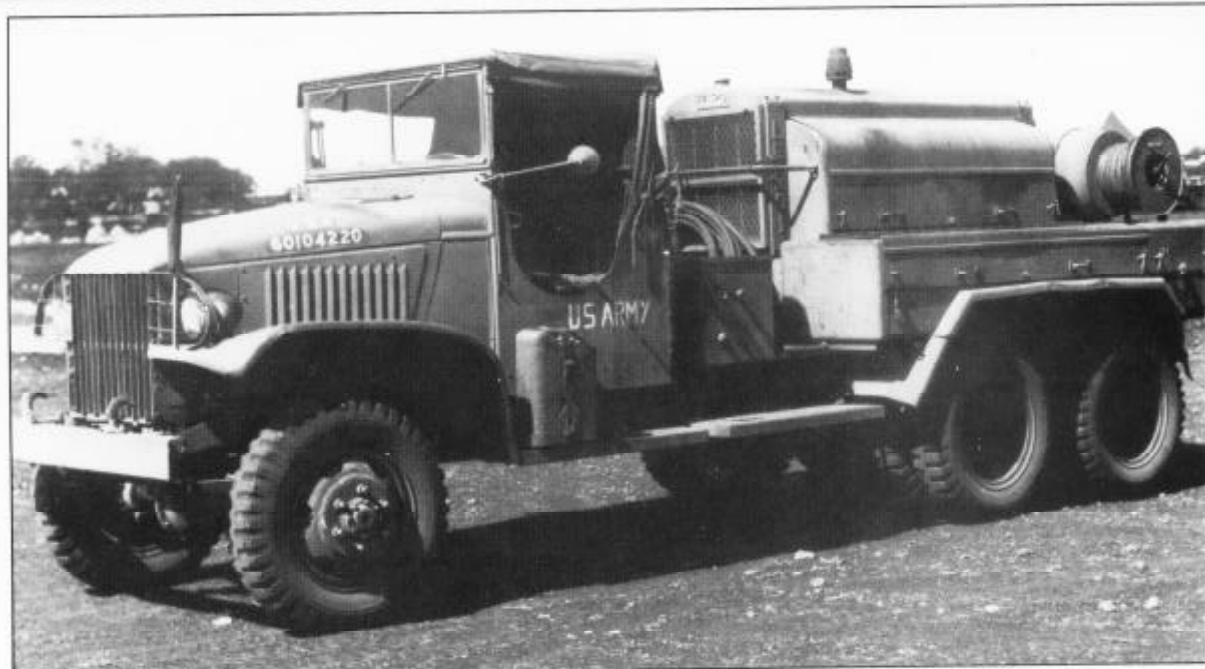
A perfectly average mid 1943 CCKW-353 Compressor Truck. It's late enough to have the gas can carriers, but not late enough to have the running board mounted pioneer tools or the late canvas. The top shown is the early one, without the metal side rail. The only options are: the unit badge and flag on the brushguard, and the kinked fenders. U.S. Army SC 380093

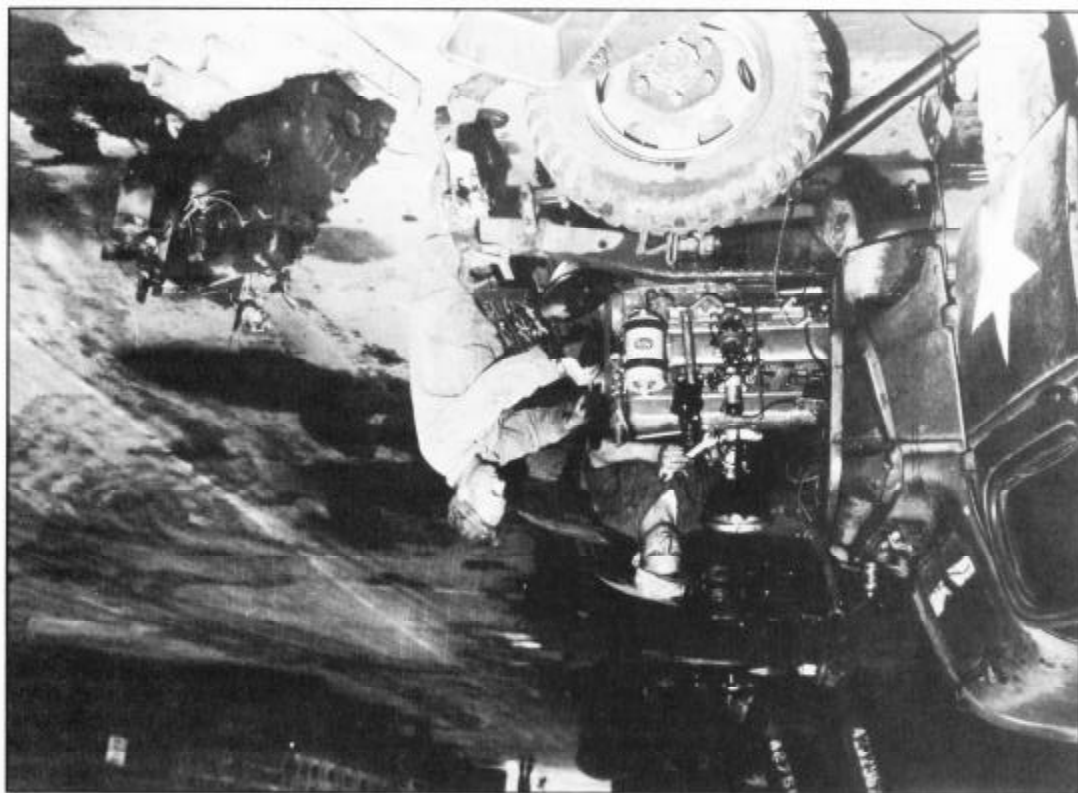
Two members of an American Ordnance company in France change a motor on a G.I. truck.
September 1944. U.S. Army SC345660

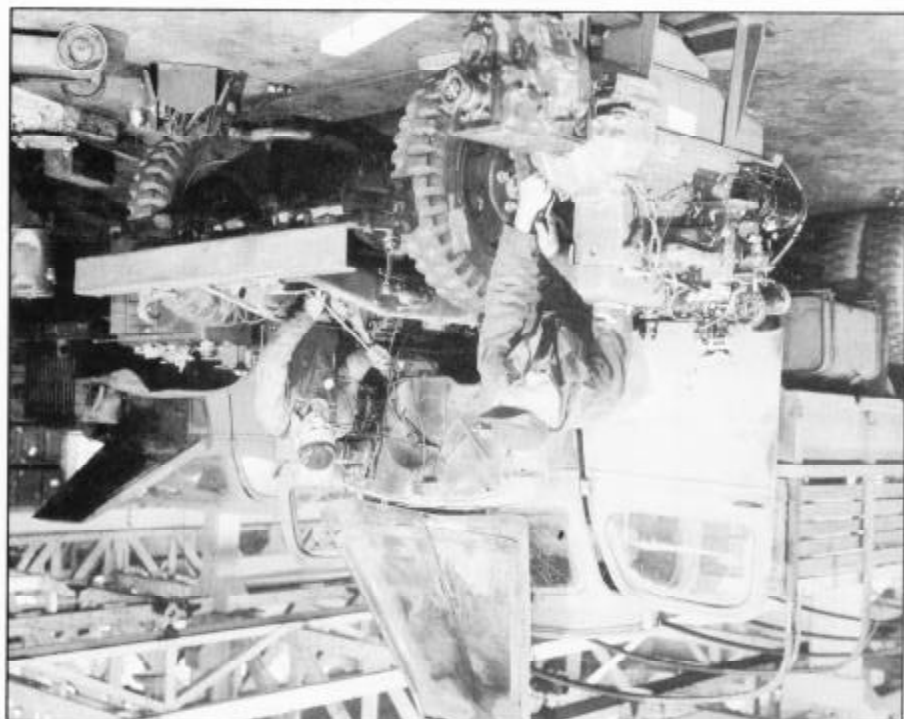
This GMC CCKW is undergoing a depot rebuild. Note decals and data plate on left side of new engine and the hip ring on the passenger side of the cab roof.
Date and place unknown.
National Archives 111-SC-320380

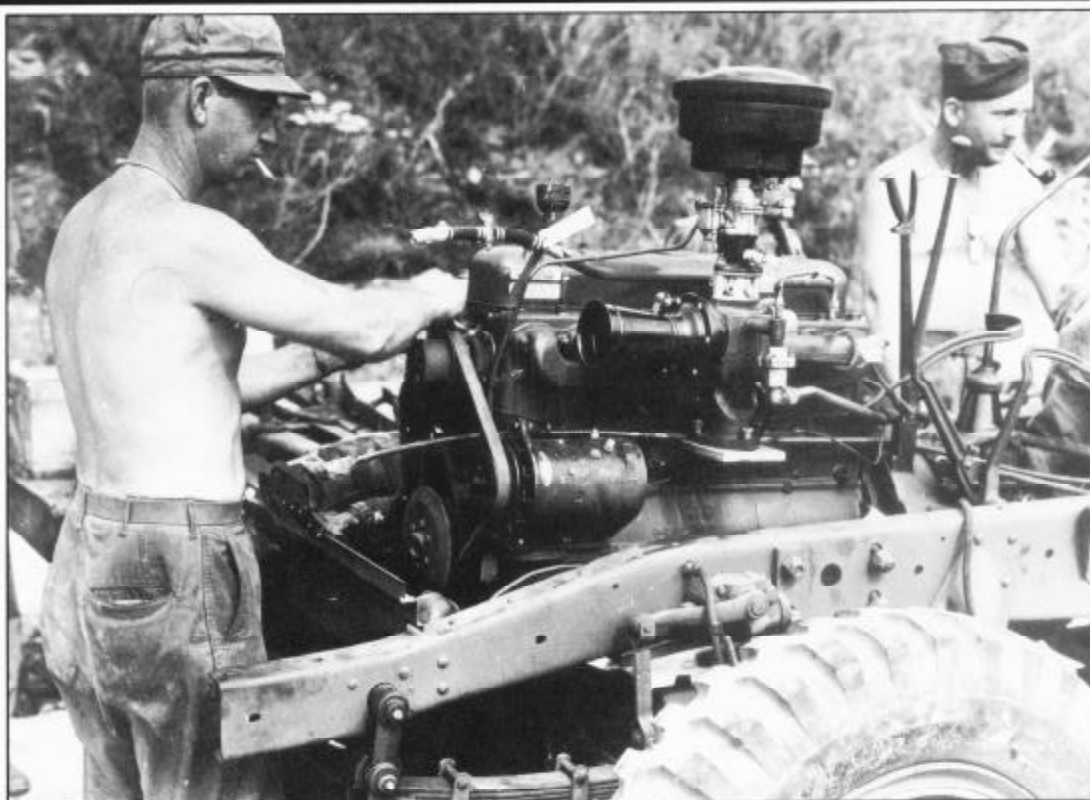
A field re-assembly of a crated GMC. Note all the shiny new parts and the octane rating and tappet setting on the valve cover. Date and place unknown.
